W0-A-0061

PRELIMINARY GEOLOGICAL  
DAM SITE ASSESSMENT REPORT  
BAMYAN PROVINCE

November 25, 2010

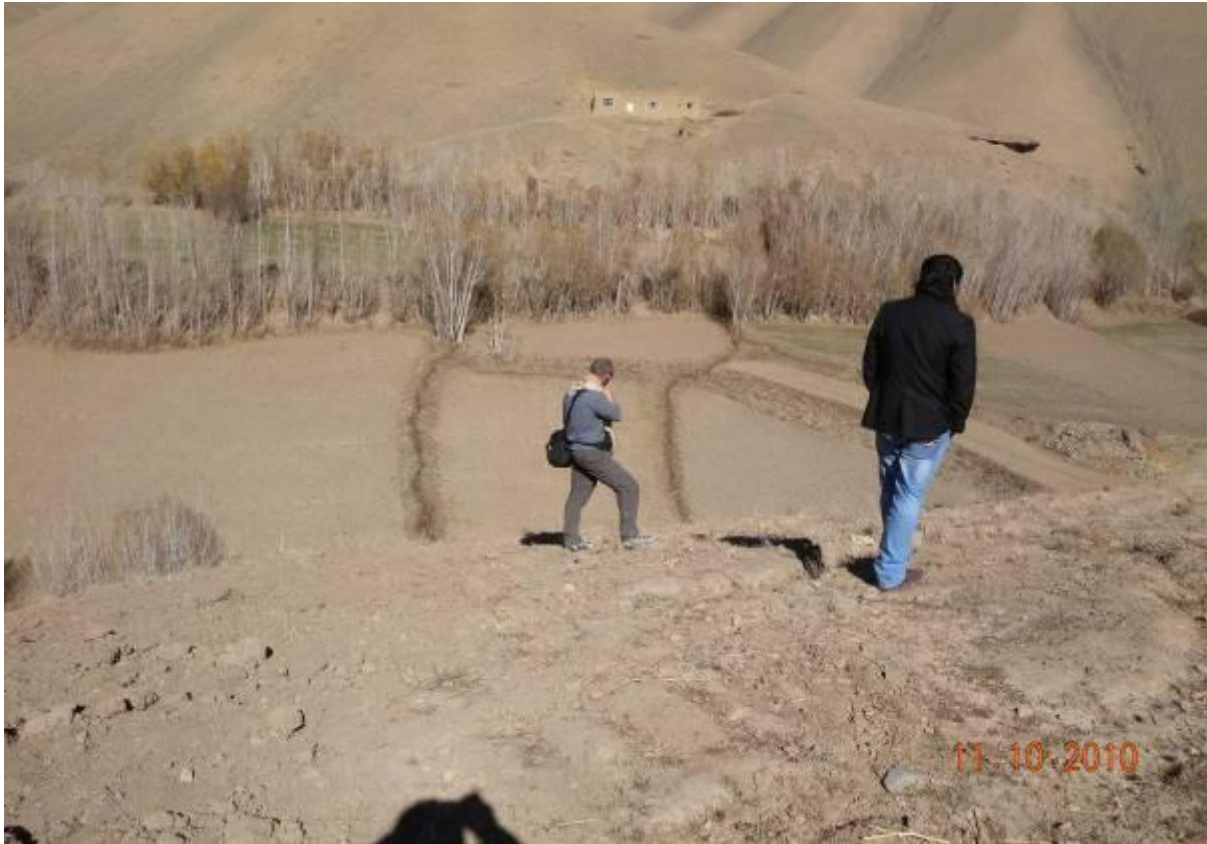
Looking north from top of south valley position

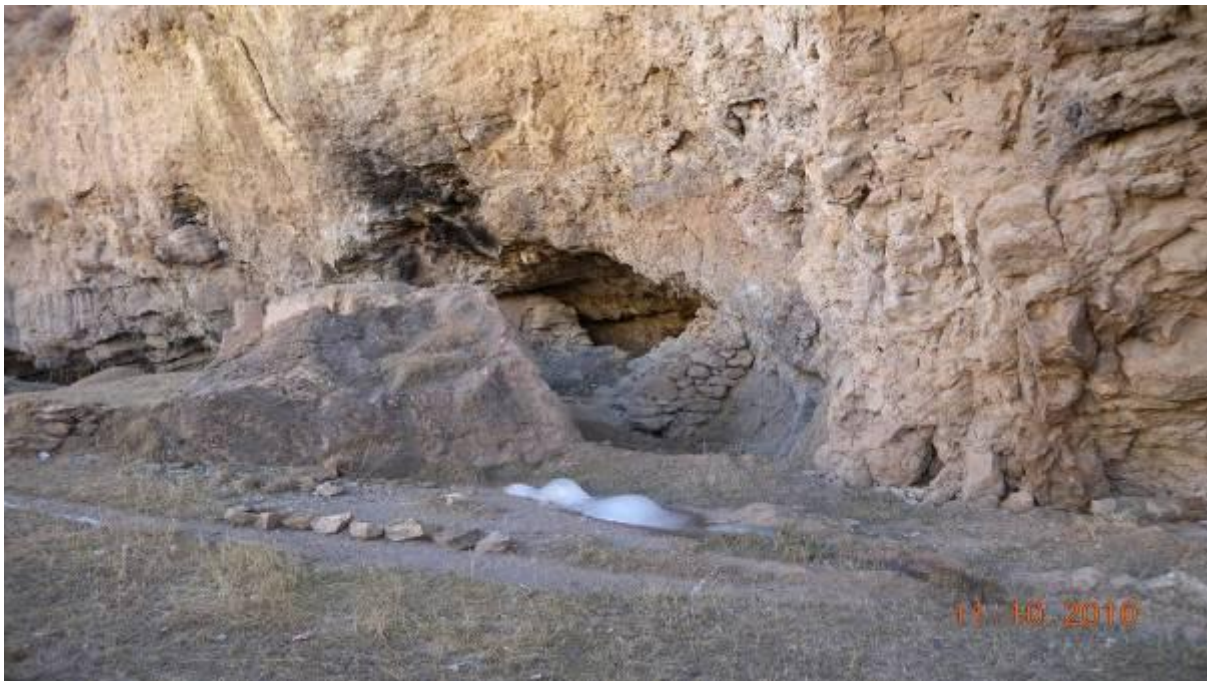
Looking southeast from south valley floor position

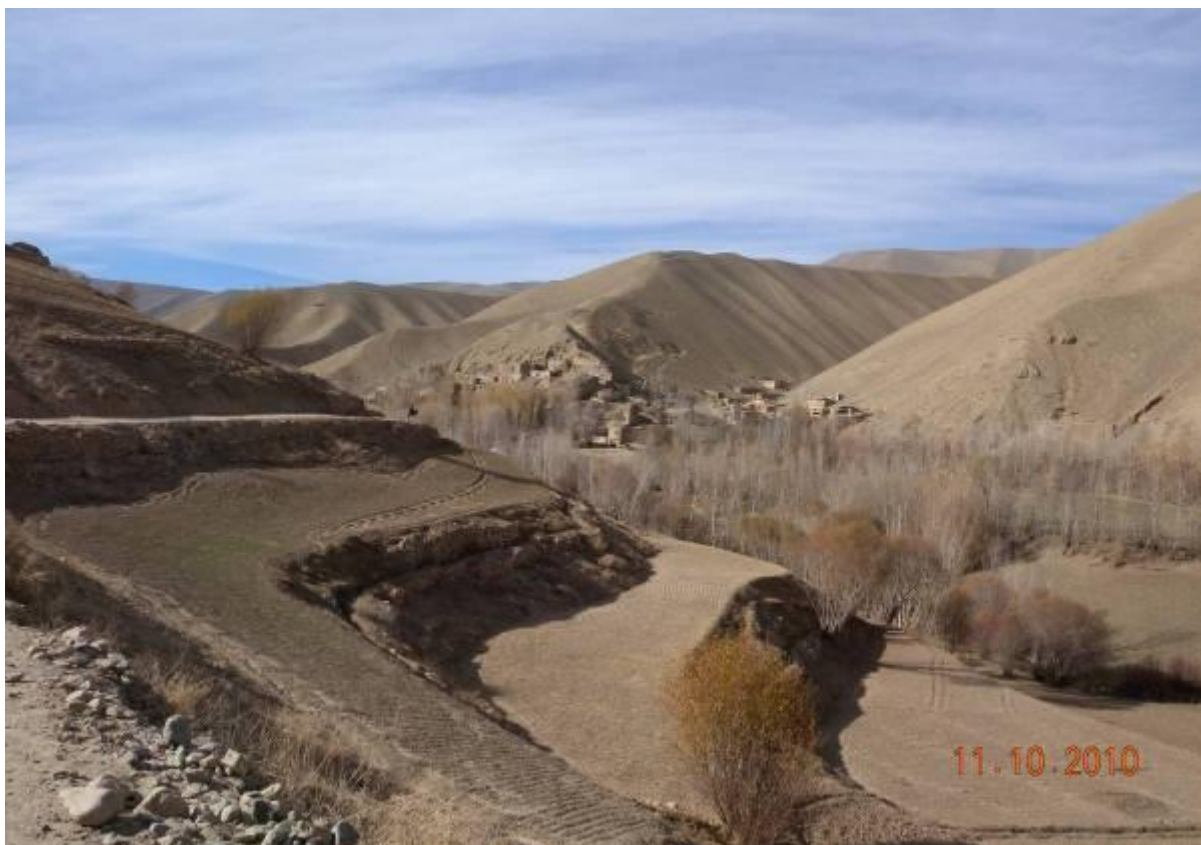
Looking west (up-valley) from top of south valley position

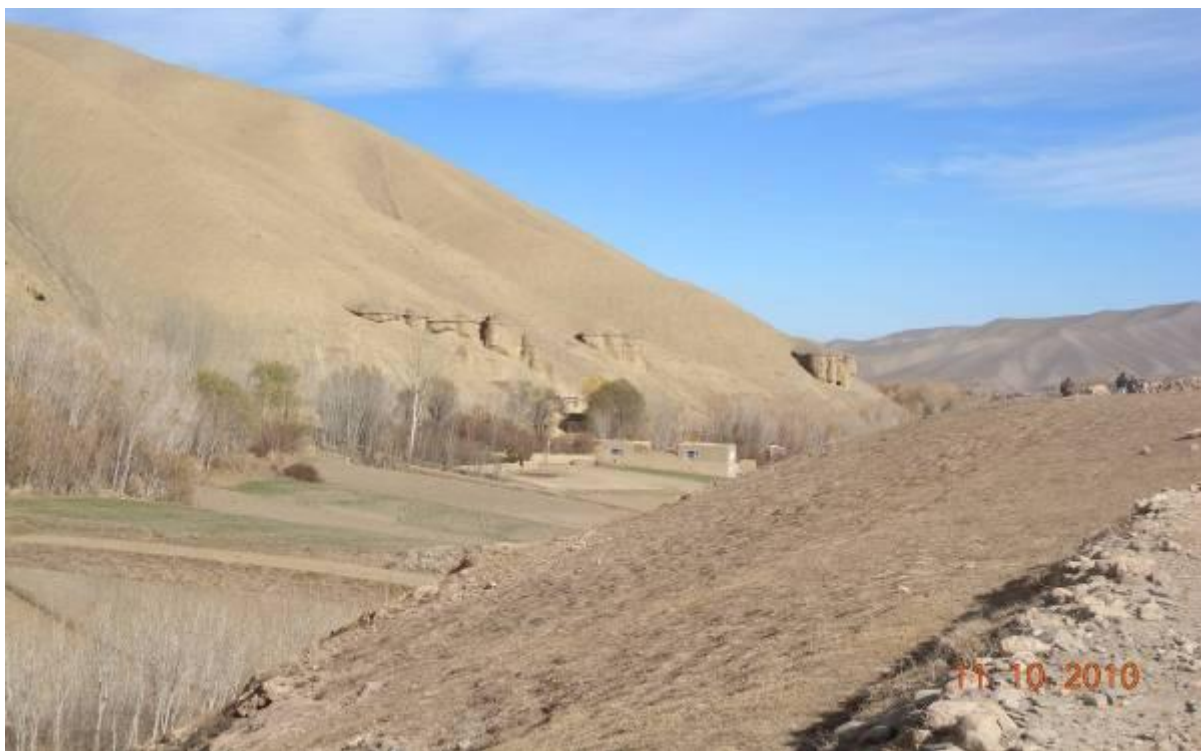
Looking down-valley (east) from top of south valley wall position

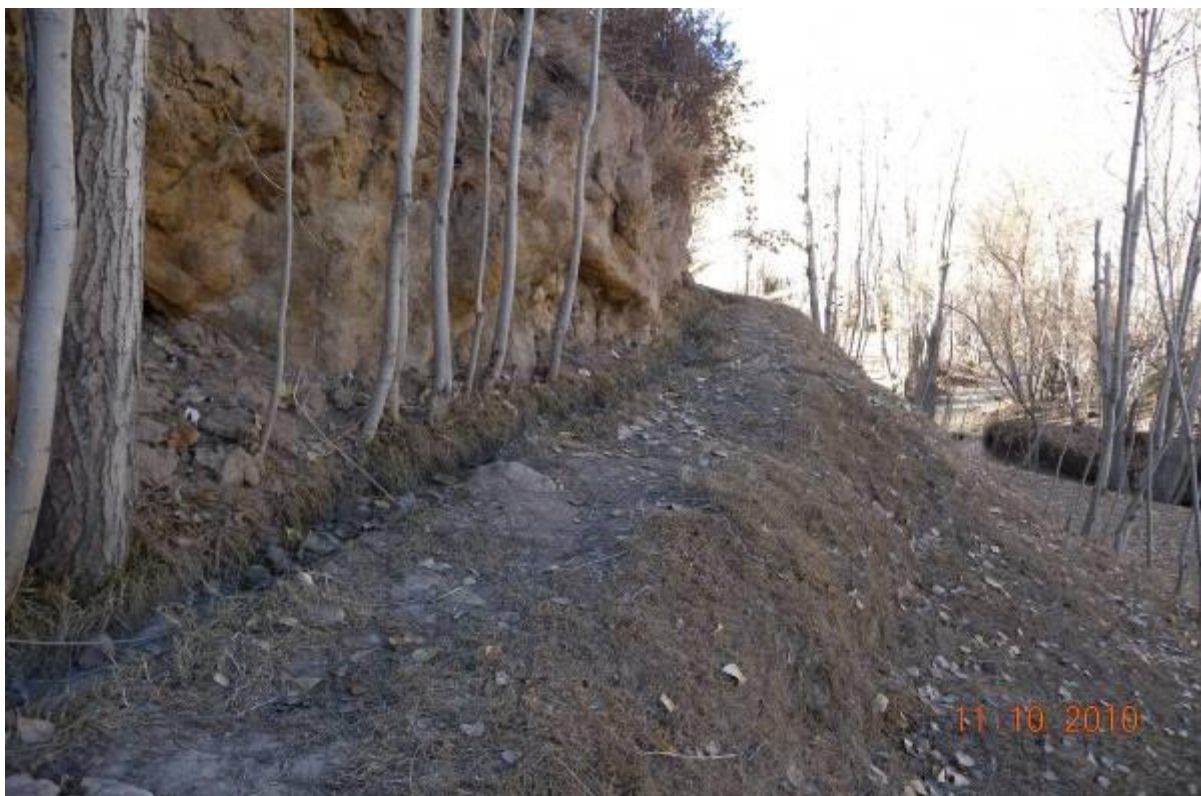
Small irrigation ditch located along base of south valley wall (looking southwest from south valley floor position)

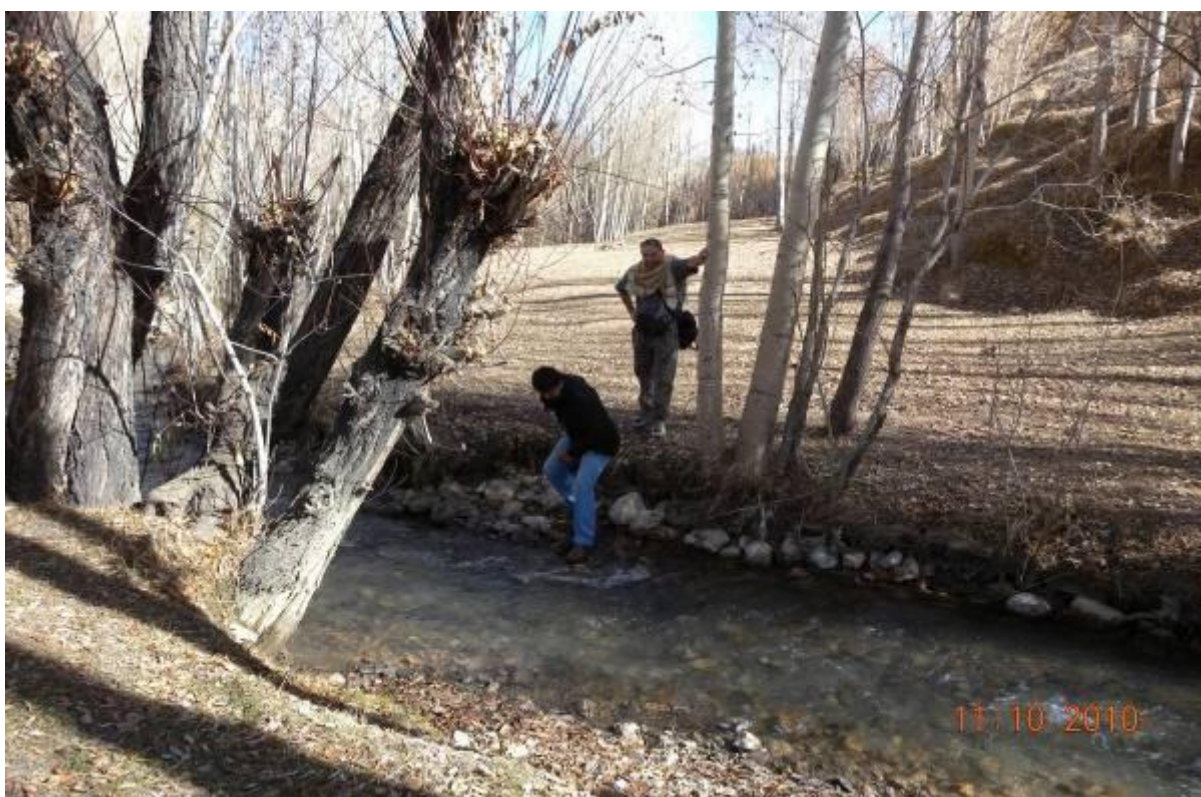
Looking northwest from south valley floor position

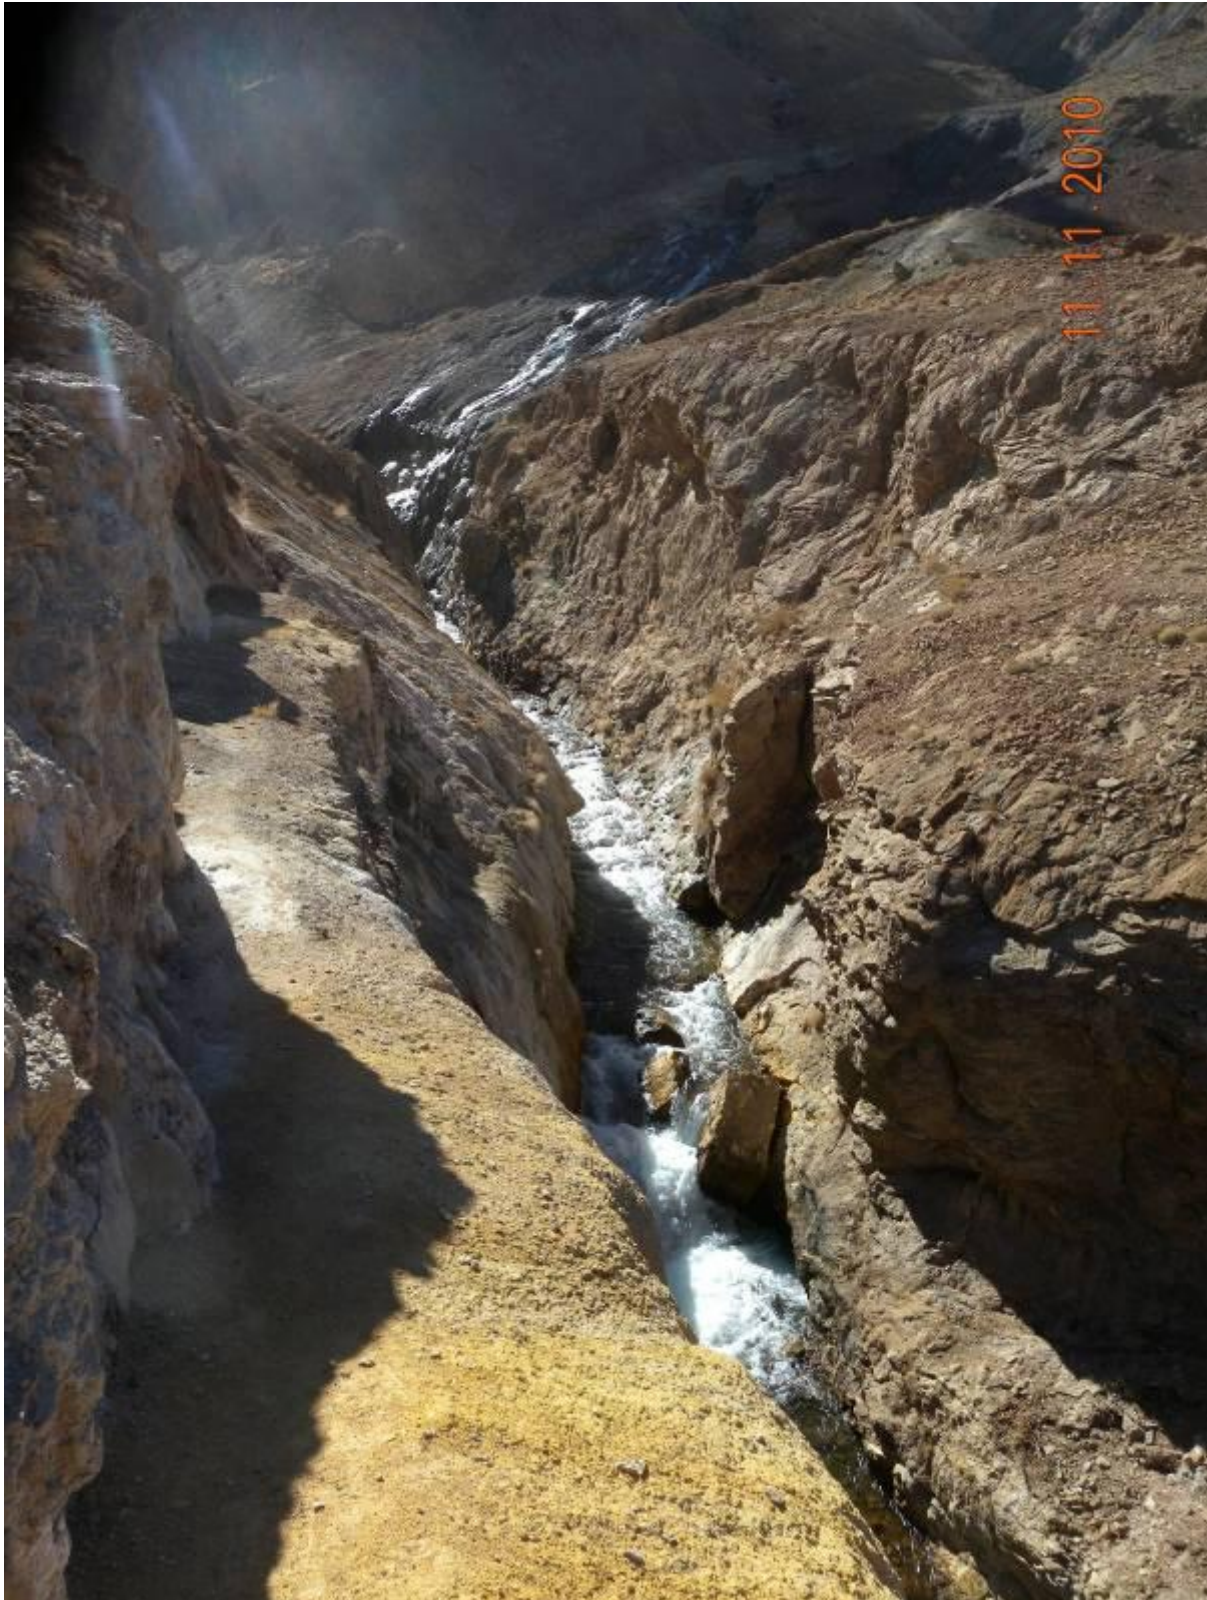
Looking south (upstream) from east bank position

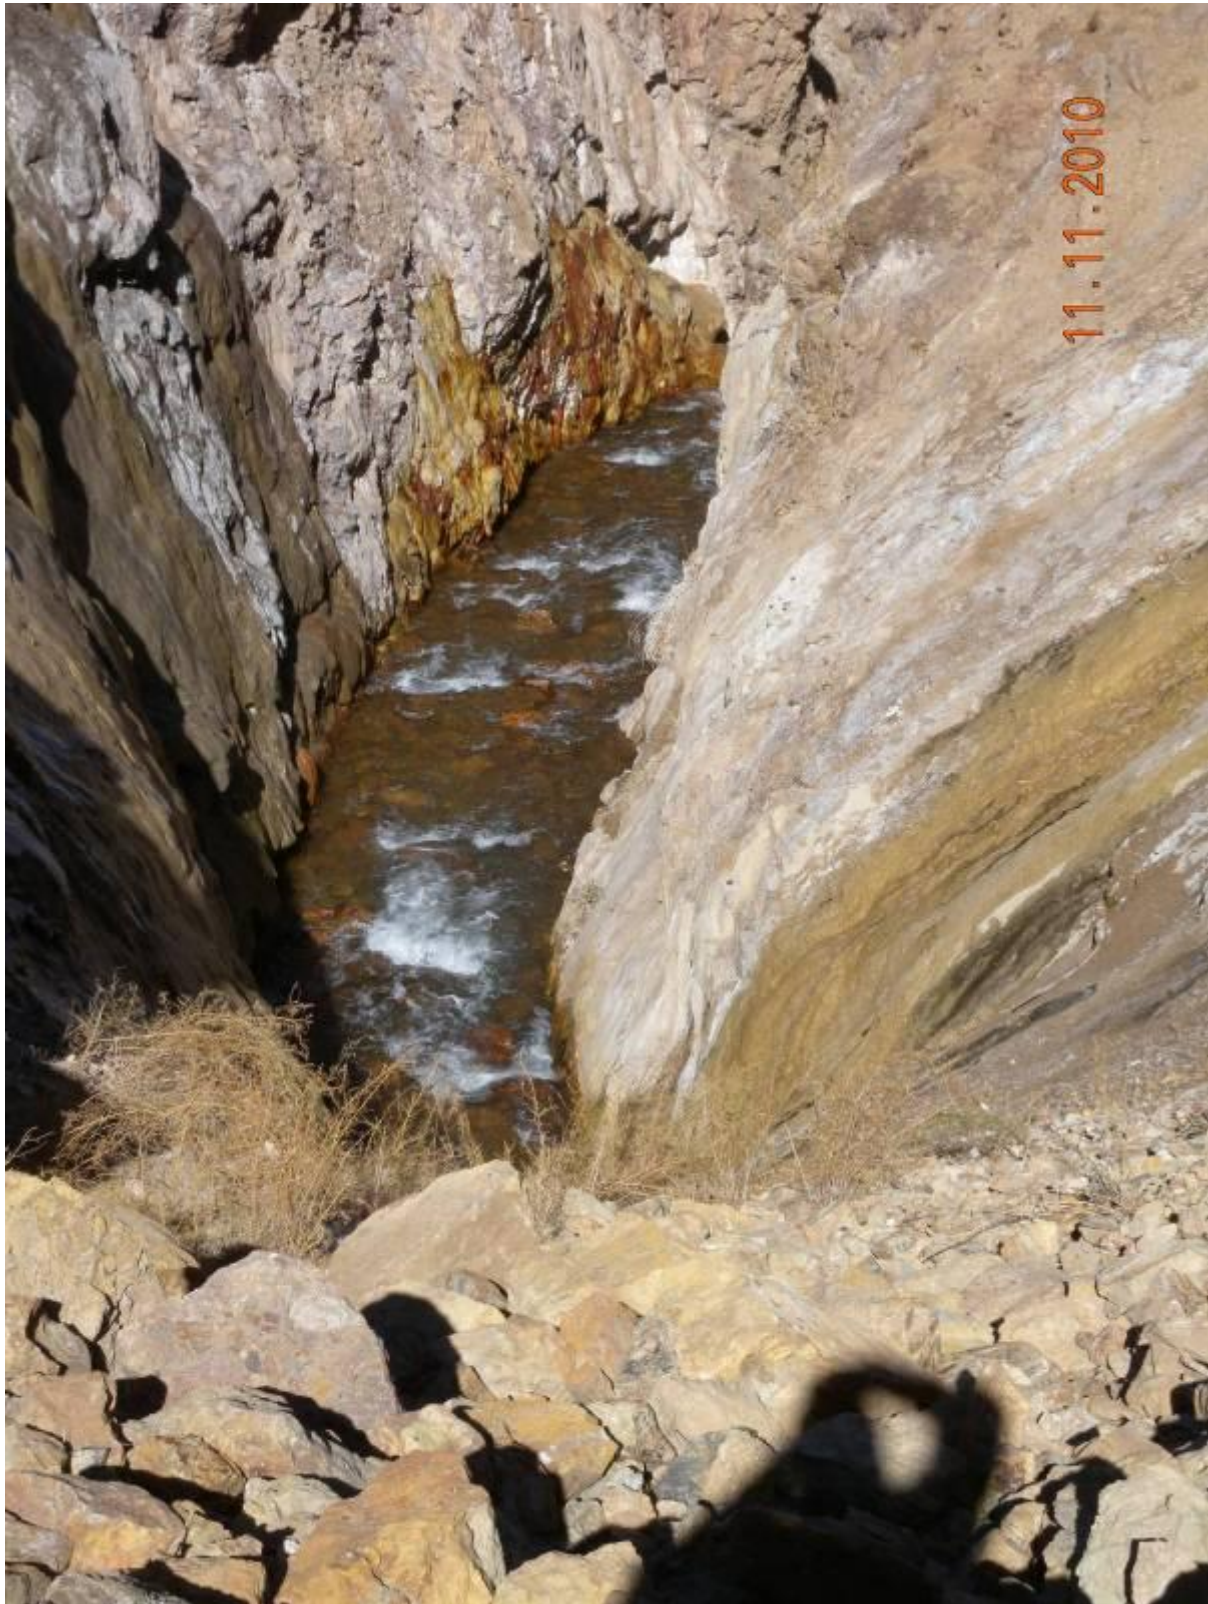
Looking north (downstream) from upstream position

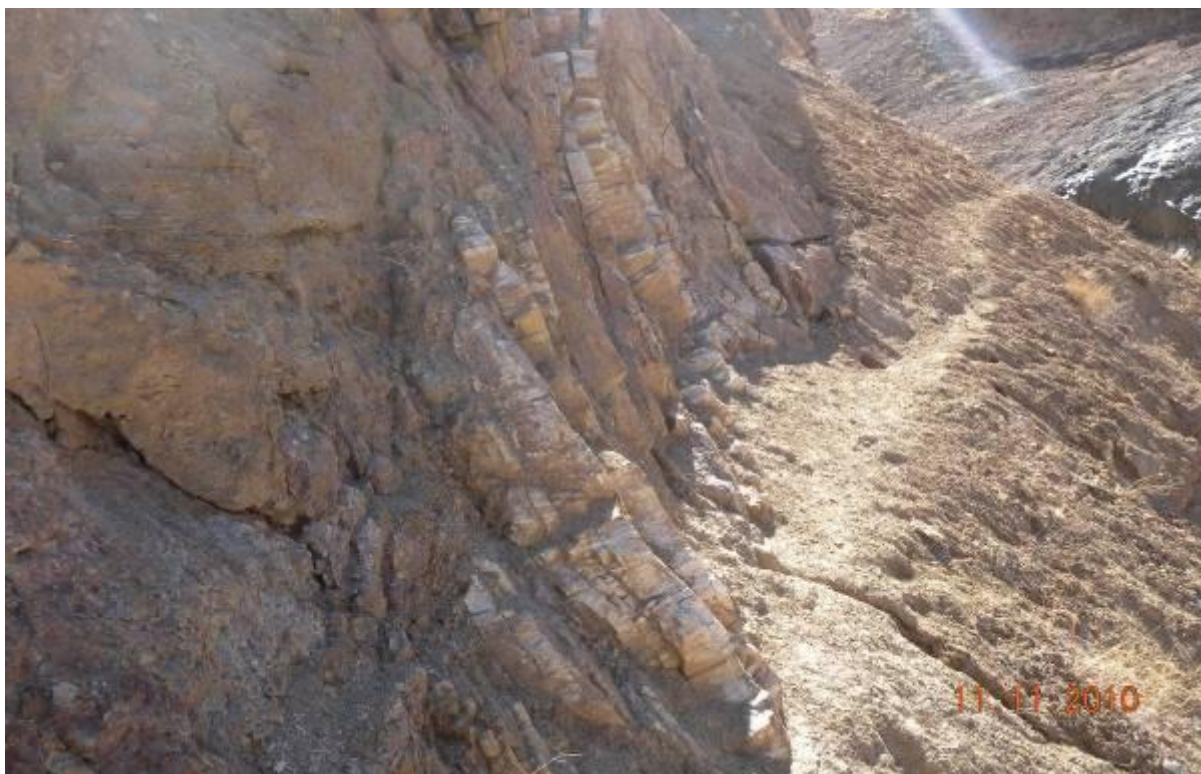
The rock outcrops observed are primarily medium to dark grey granite with reddish-brown to cream staining in areas. Extremely thick travertine and iron precipitate deposits (approximately 0.1 m to 0.3 m) were noted covering the eastern wall, making identification of the underlying strata difficult. There was evidence of warm seeps along the east wall as well. An area of medium-to-coarse grained reddish orange sandstone was noted underneath the travertine deposits on the east wall slightly downstream of the proposed dam axis. Due to the layer of travertine on the east wall face, no strike or dip measurements could be made. The general strike and dip of the west wall was recorded as 320°/15° E. The visible joints appeared random in orientation. Joint gaps were observed to be tight, with little or no infilling. No evidence of significant faulting was observed.

Looking south from east bank position (travertine deposits)

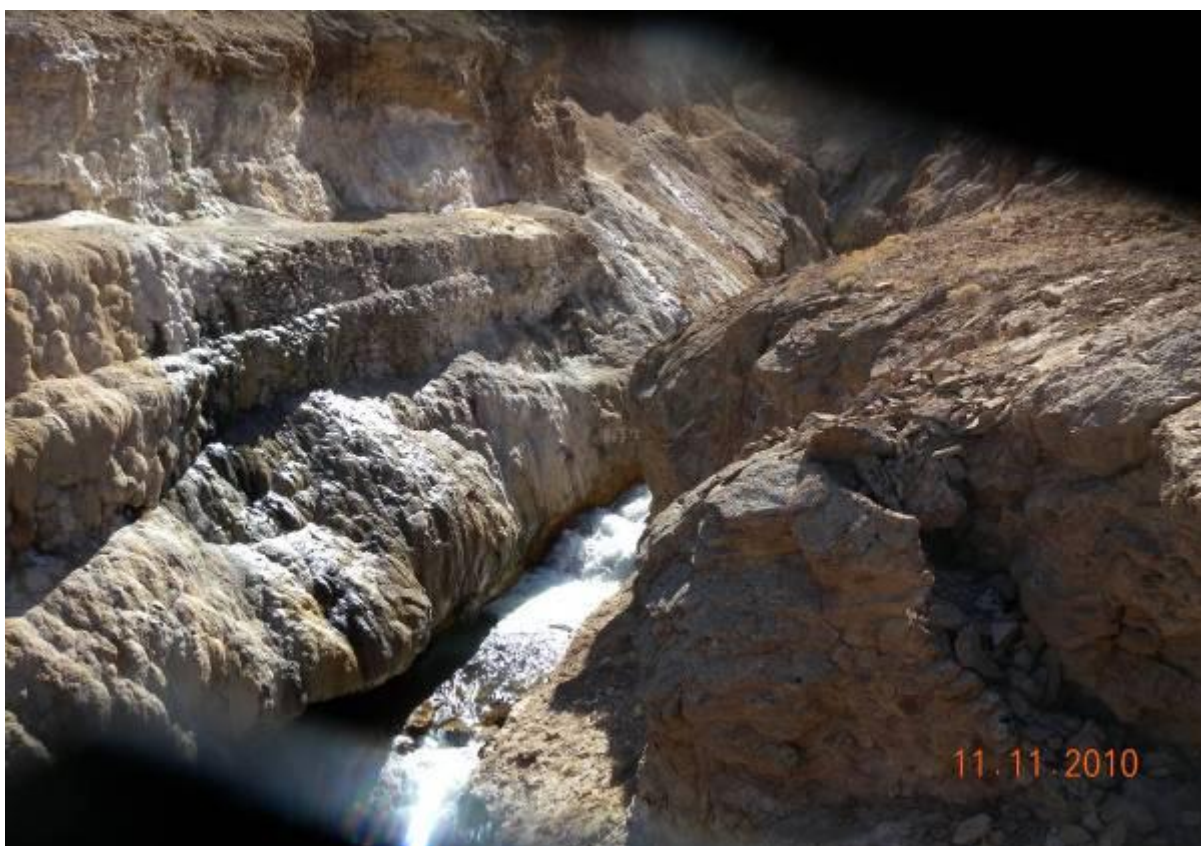
Looking north from east bank position

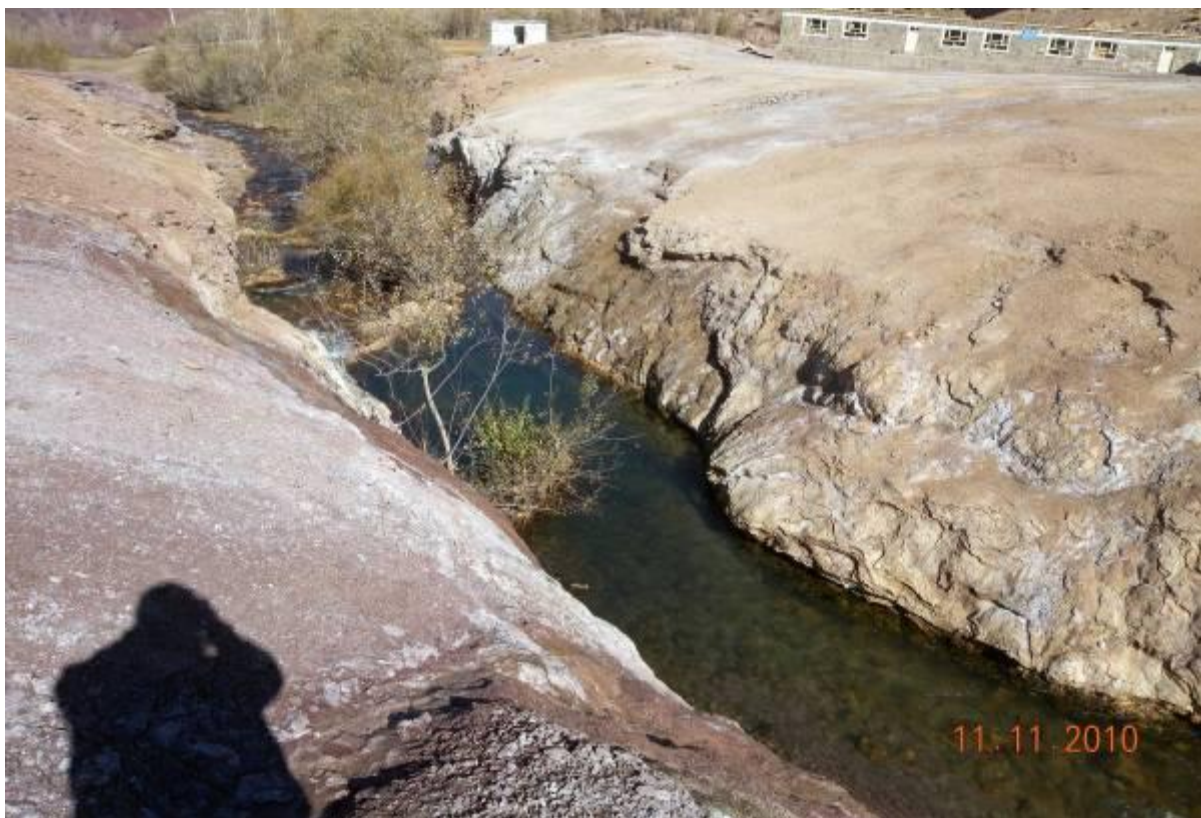
Looking north (downstream) from west bank position (Pay-i-Mori School in background)

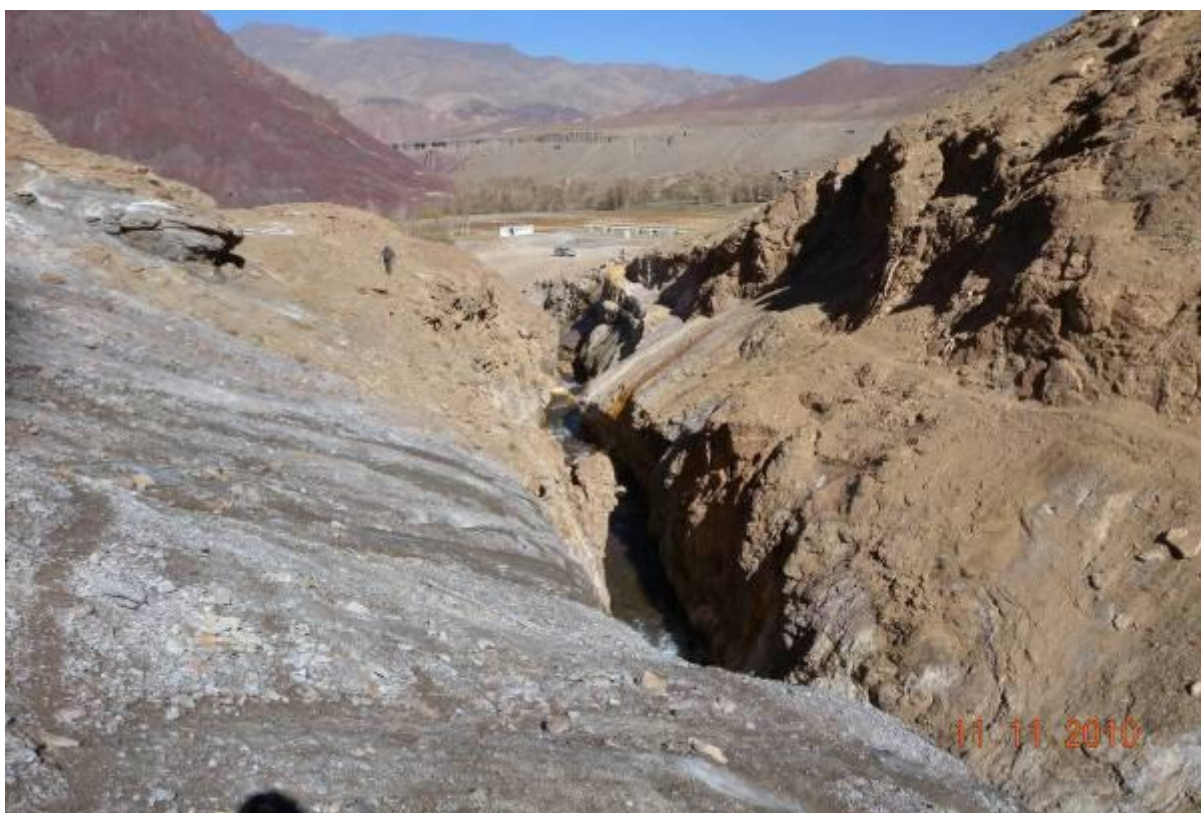
Looking downstream (north) from west bank (Pay-i-Mori School in background)

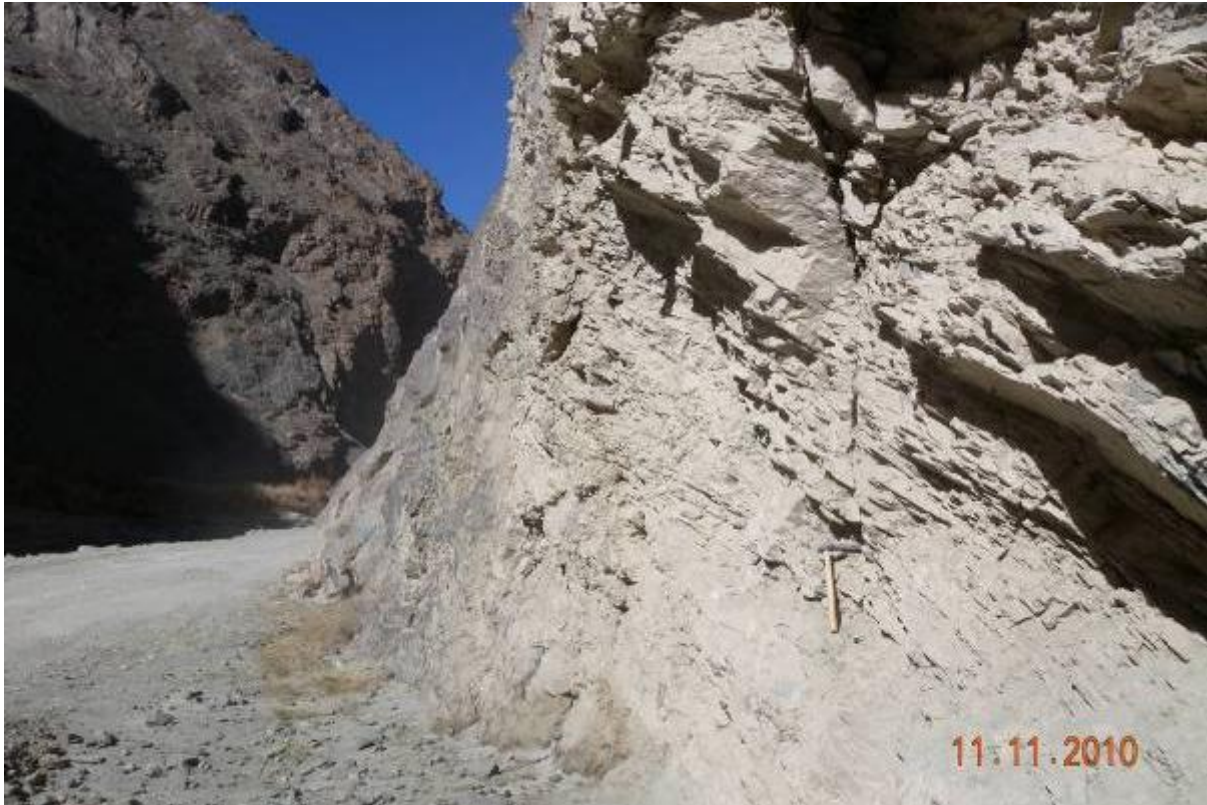
Looking north (downstream) from east bank position

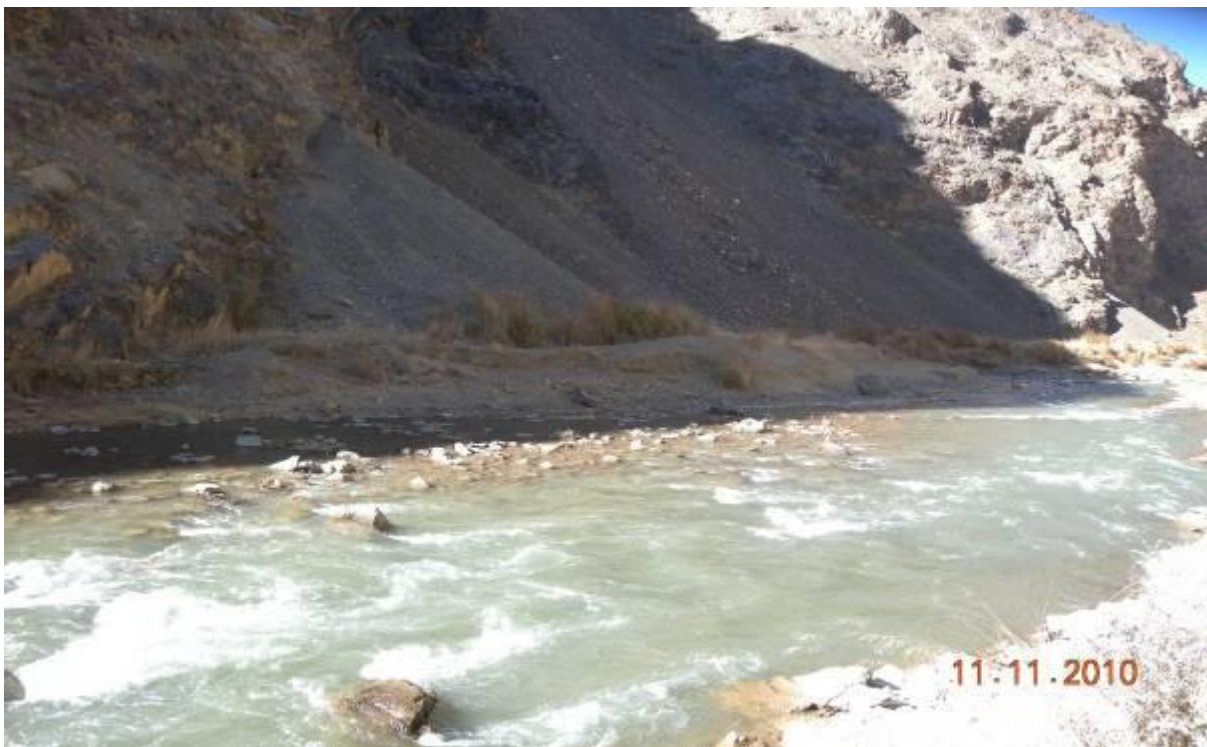
Looking northwest from east bank position

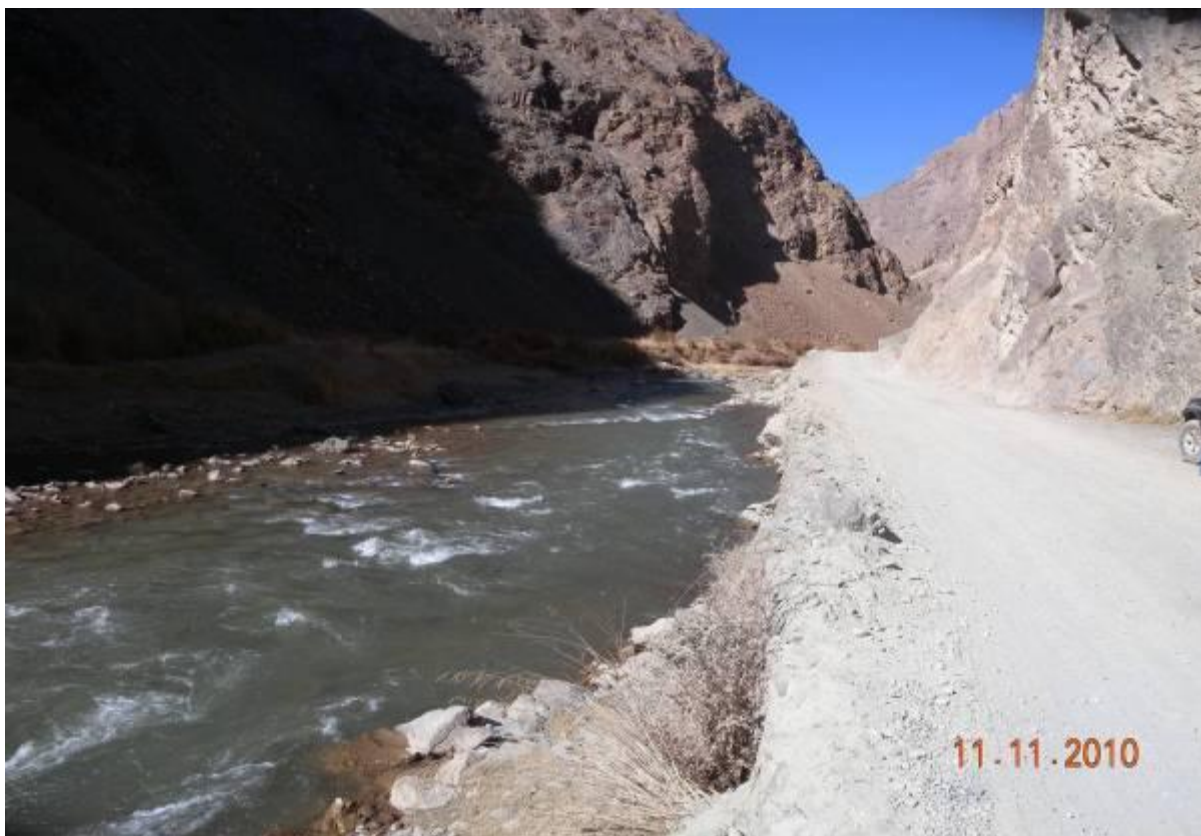
Looking north from the east bank position

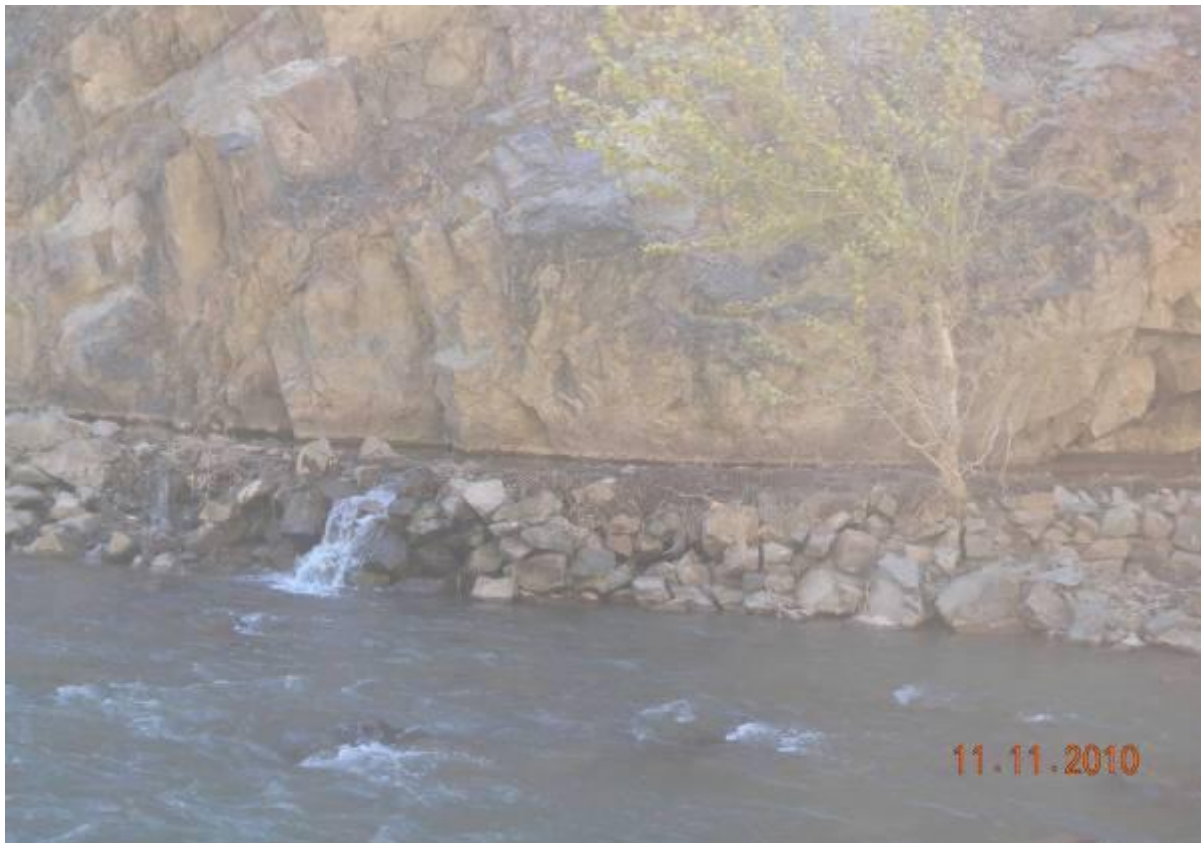
Looking west from east bank position. (Note existing irrigation canal.)

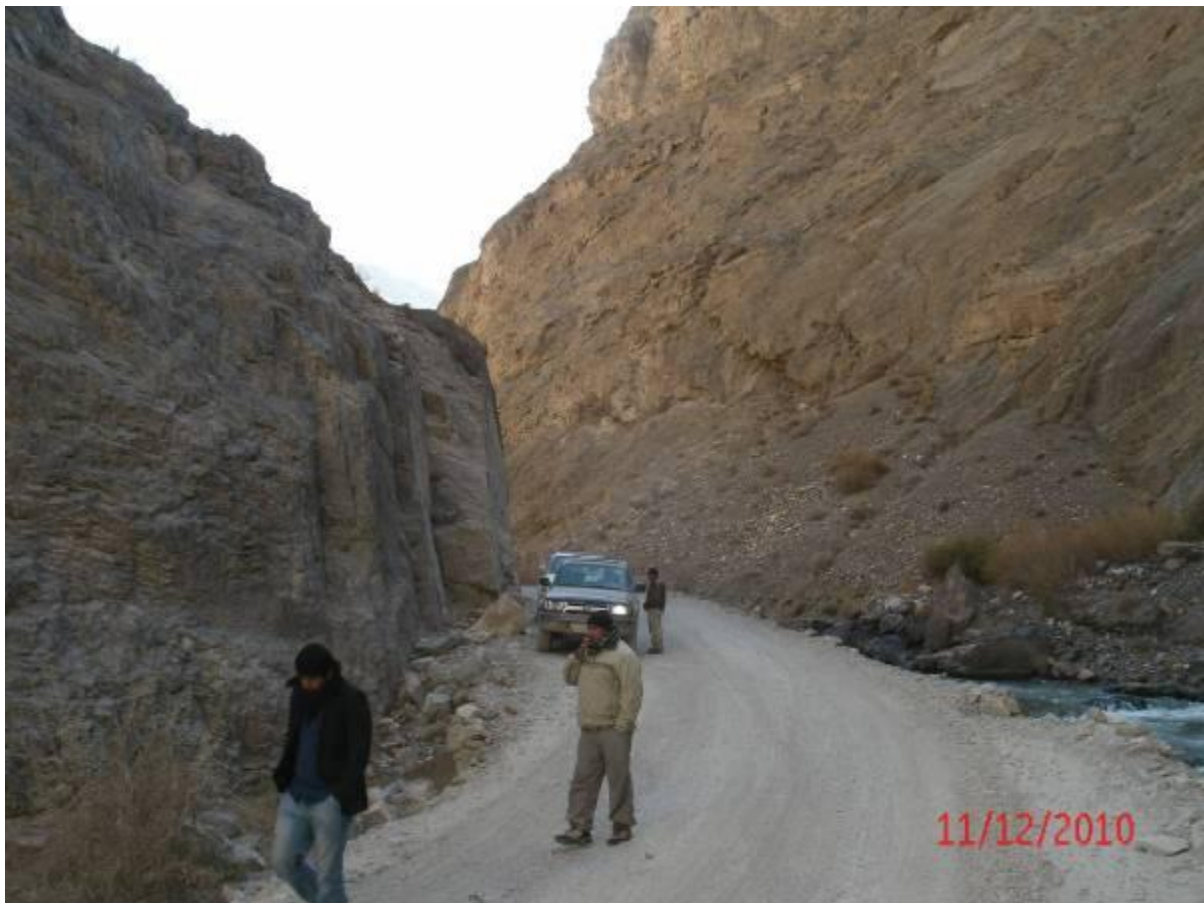
Looking east (upstream) from the north bank position

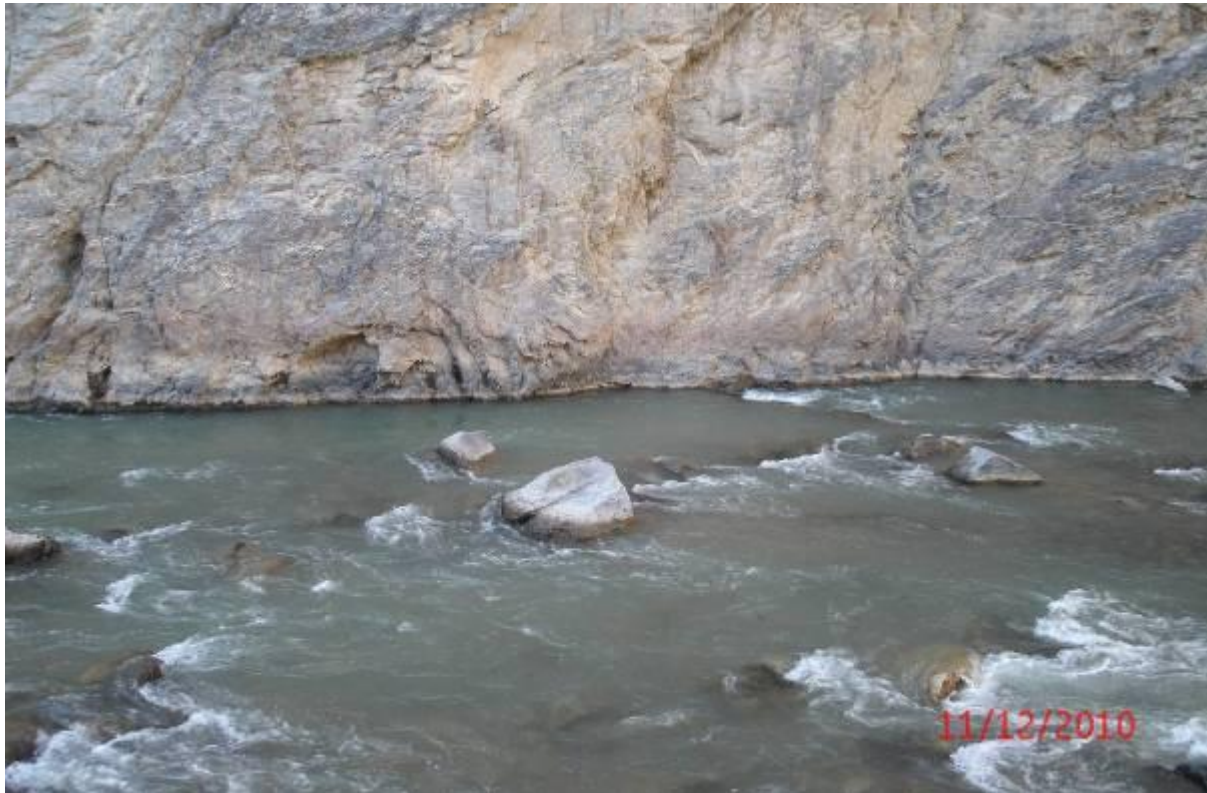
Looking south from north bank  
position

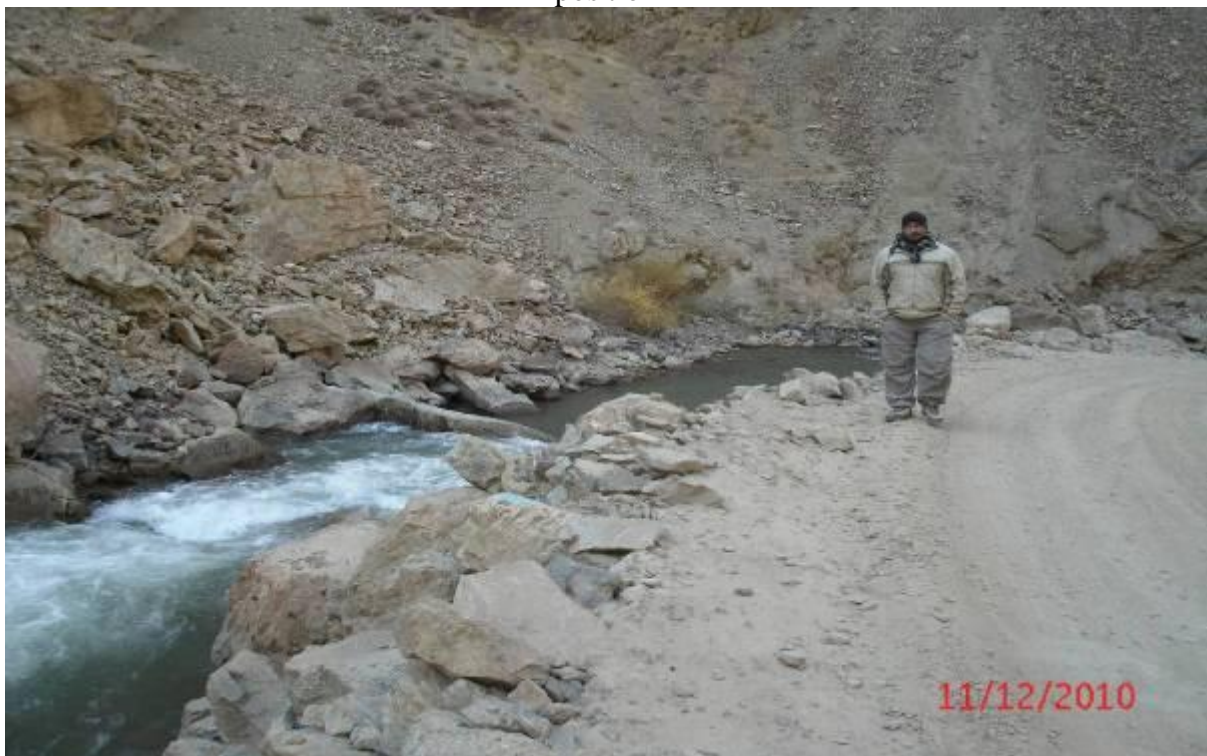
Looking west (downstream) from north bank position

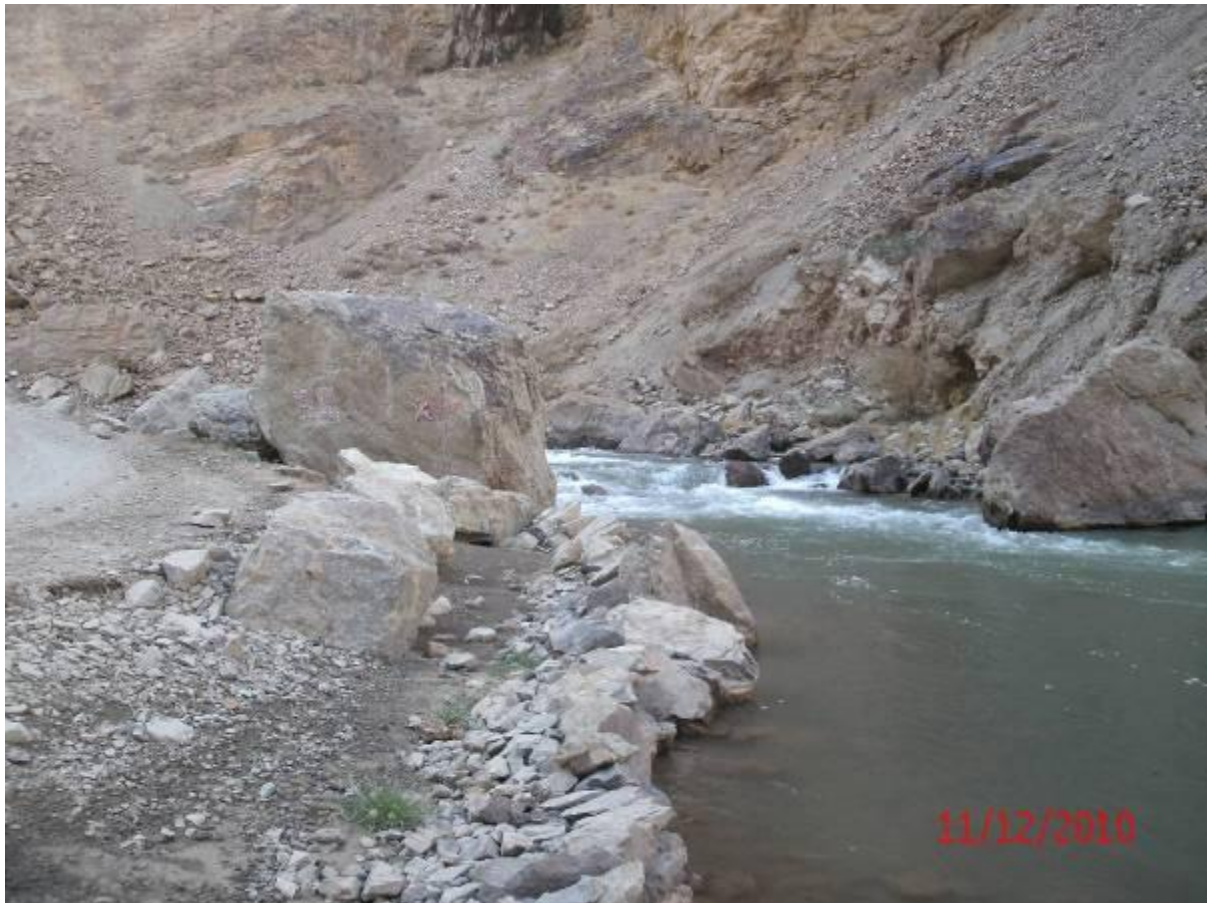
Looking south (downstream) from northeast bank position

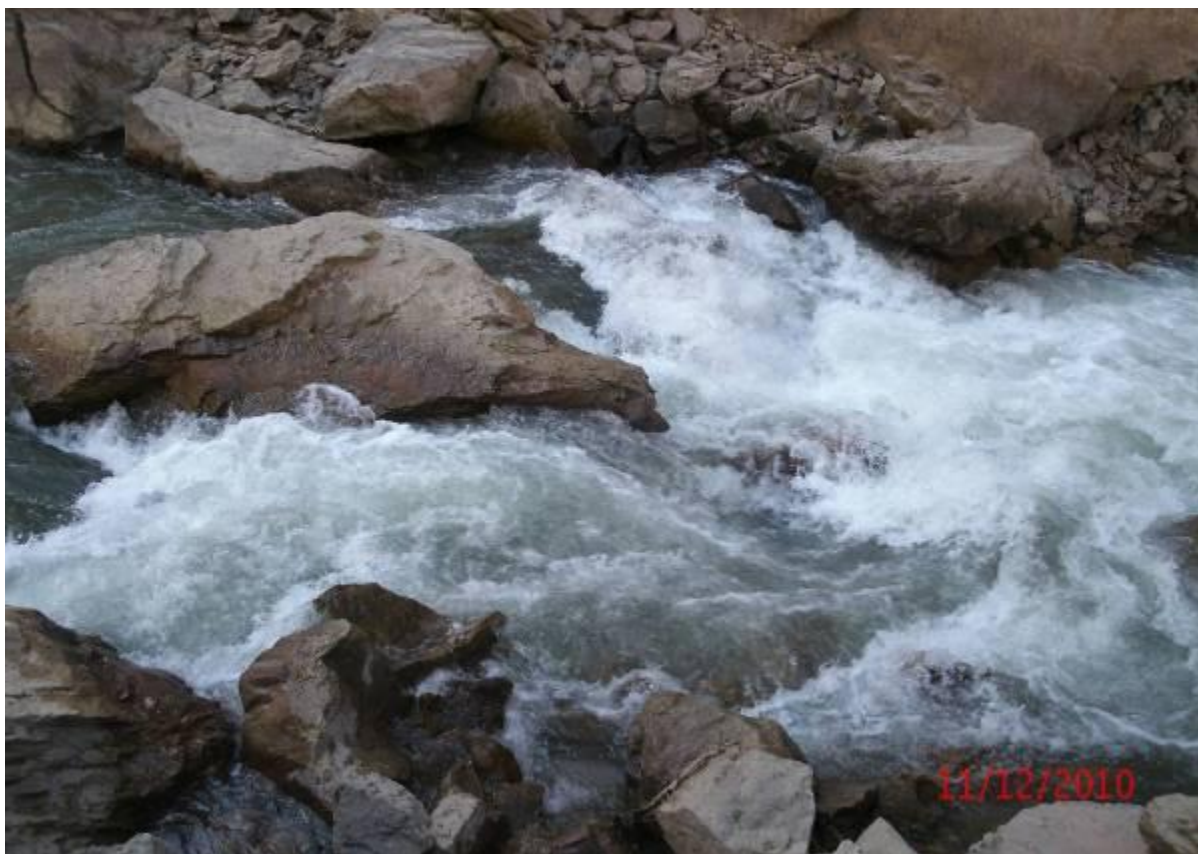
Looking southwest from northeast bank position
